Report No. FAA-RD-79-28

SURVEYS OF GROOVES IN 19 BITUMINOUS RUNWAYS

Richard Melone
Naval Air Engineering Center
Lakehurst, N. J. 08733

March 1979

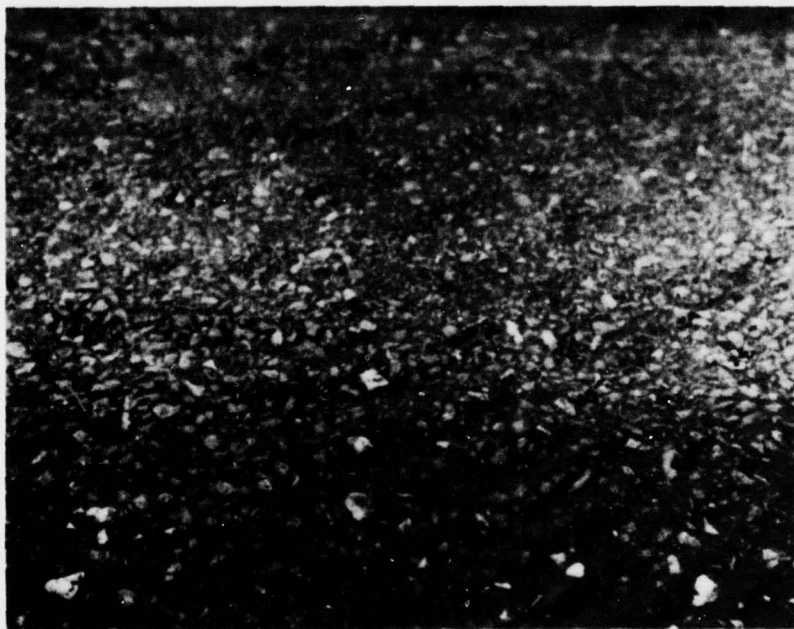
A. WEAR -- Groove depth measuring 1/8 inch or less (all were supposed to be 1/4 inch). (See Figure 1)

e. WEAR - Wear is the most common of the problems affecting grooved bituminous runways. High-use runways and older runways naturally show a greater amount of wear. There is more wear on runways having a small pitch and on the longer runways.

Figure 1 - Wear (Groove Depth of 1/8 Inch or Less) Identified During Runway Survey

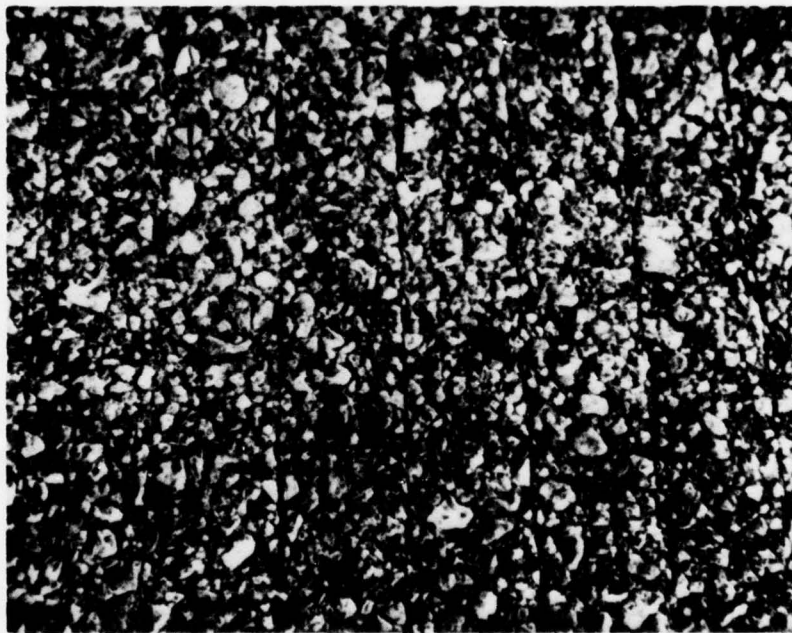
Figure 2 - Closing (Groove Width of 3/16 Inch or Less) Identified During Runway Survey

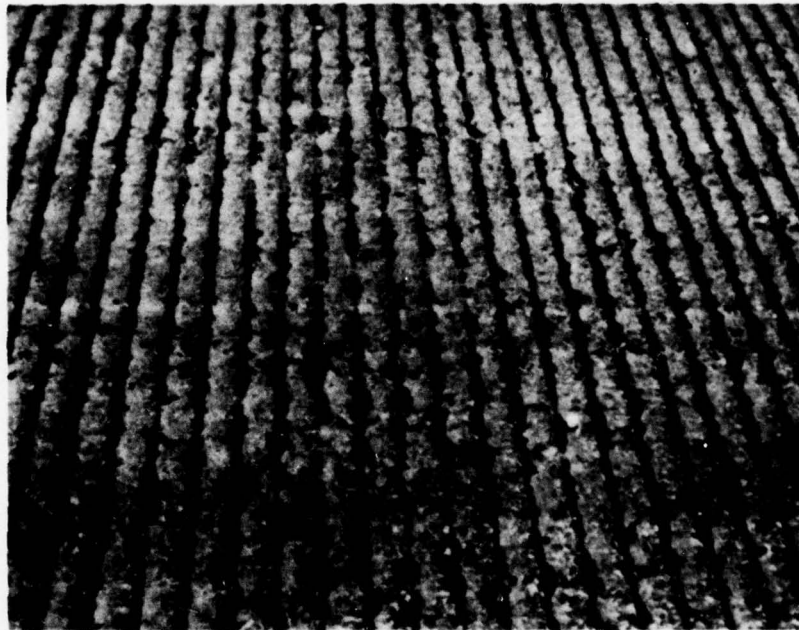
j. RUBBER - Rubber deposits and clogging of grooves is perhaps the most serious groove problem of all. Rubber removal operations must be regularly scheduled at most high-use airports. Considerable amounts of rubber were found clogging grooves in threshold and braking areas.

Figure 3 - Rubber Found in Grooves of Runway During Survey

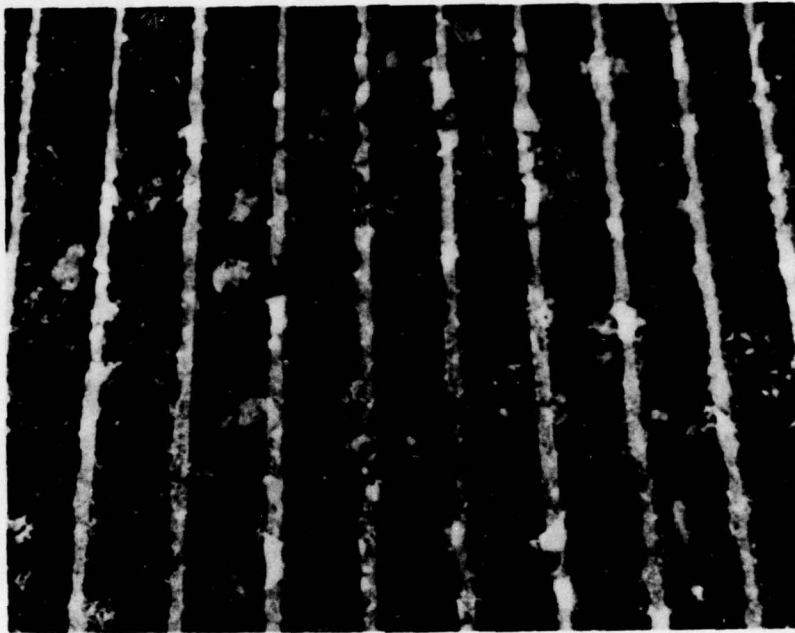
g. SPALLING - Among the least common of problems, spalling was found mainly on runways at high-use airports and only in cold weather areas.

Figure 8 - Spalling Identified During Runway Survey

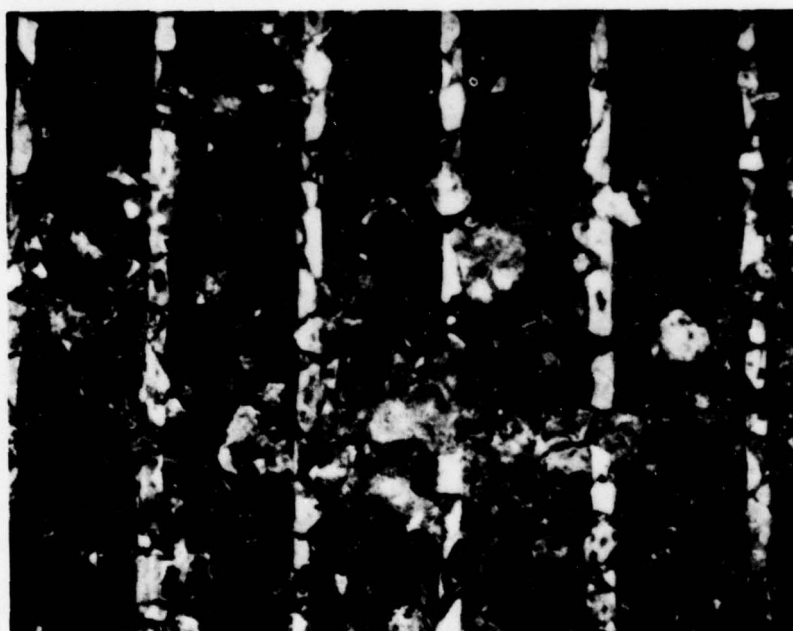
f. EROSION - Erosion is a relatively uncommon problem occurring at only 2 of 19 runways surveyed. Erosion is most likely dependent on deficiencies in the bituminous mix rather than traffic or climatic conditions.

Figure 10 - Erosion Discovered on Runway During Survey

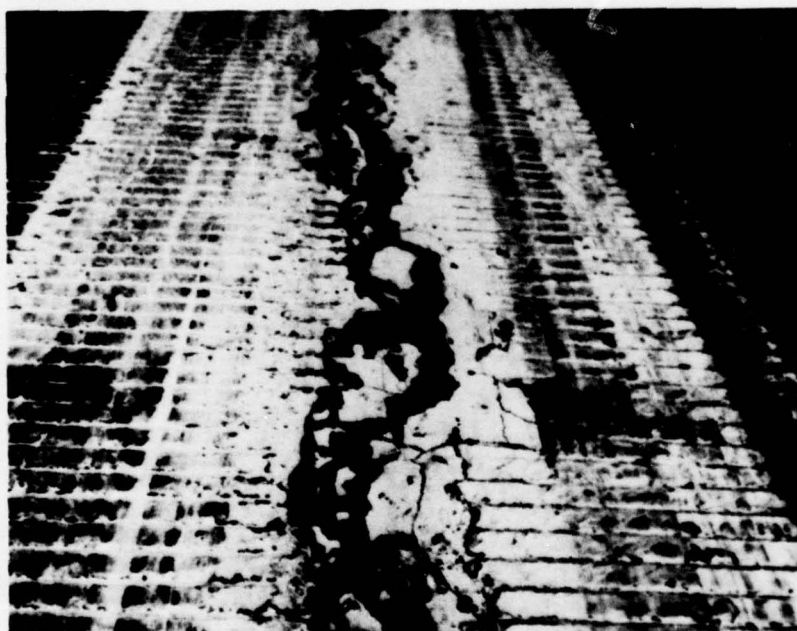
At several of the runways surveyed, extensive cracking along cold seams and/or along the centerline light wiring trough necessitated repairing the damaged areas with cold patch (see Figures 11 & 12). The patches were typically 10 to 20 feet from the centerline and ran parallel to the centerline for hundreds of feet. No regrooving was attempted where these patches were made. The portion of the existing grooves between the centerline and the patched areas cannot effectively drain. Some effort should be made to regroove these patched areas to match the existing pattern as closely as possible.

Figure 11 - Cold Seam Cracking Discovered During Runway Survey

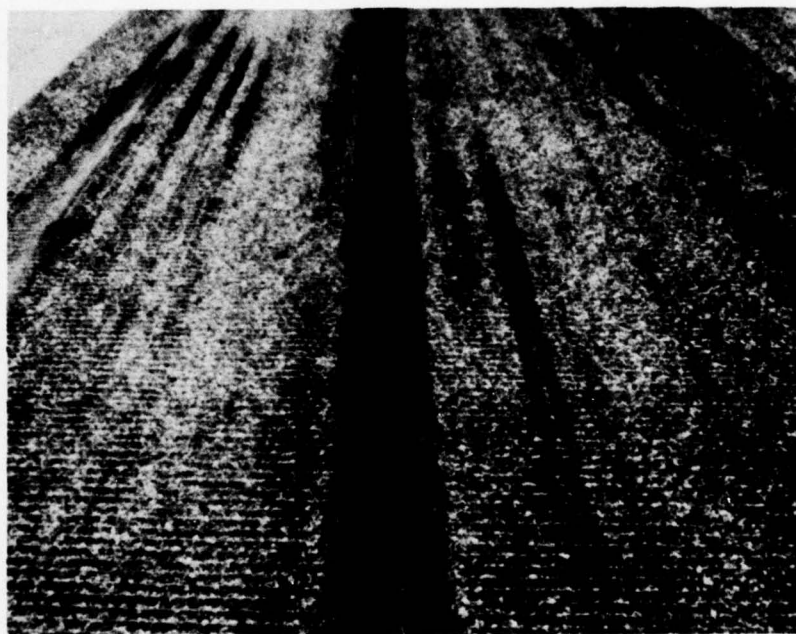
Figure 12 - Ungrooved Patch Discovered During Runway Survey
